DEPARTMENT OF TRANSPORTATION**DIVISION OF ENGINEERING SERVICES**

Contract #: 04-0120F4Cty: SF/ALA Rte: 80 PM: 13.2/13.9File #: 1.28**WELDING INSPECTION REPORT****Resident Engineer:** Pursell, Gary**Address:** 333 Burma Road**City:** Oakland, CA 94607**Report No:** WIR-016385**Date Inspected:** 21-Aug-2010**Project Name:** SAS Superstructure**OSM Arrival Time:** 630**Prime Contractor:** American Bridge/Fluor Enterprises, a JV**OSM Departure Time:** 1500**Contractor:** American Bridge/Fluor Enterprises, a JV**Location:** Jobsite**CWI Name:** See below**CWI Present:** Yes No**Inspected CWI report:** Yes No N/A**Rod Oven in Use:** Yes No N/A**Electrode to specification:** Yes No N/A**Weld Procedures Followed:** Yes No N/A**Qualified Welders:** Yes No N/A**Verified Joint Fit-up:** Yes No N/A**Approved Drawings:** Yes No N/A**Approved WPS:** Yes No N/A**Delayed / Cancelled:** Yes No N/A**Bridge No:** 34-0006**Component:** SAS OBG**Summary of Items Observed:**

WELDING INSPECTION REPORT

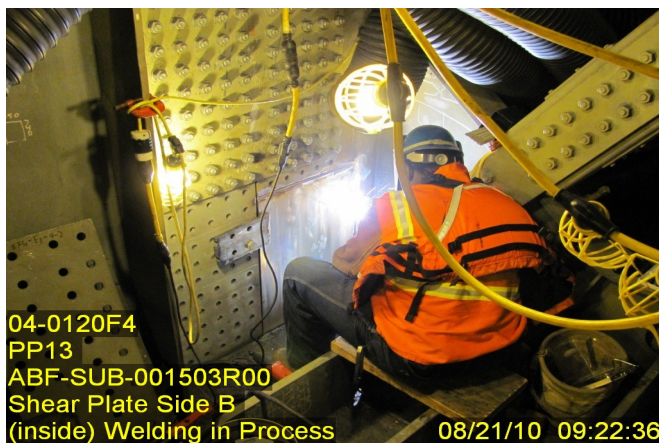
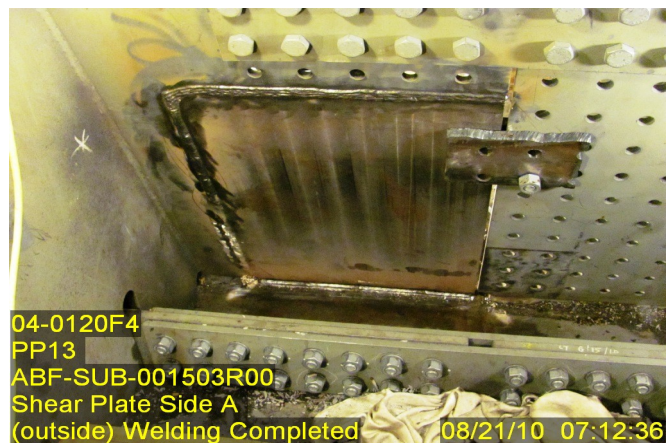
The QAI periodically observed AB/F approved welder Fred Kaddu (ID 2188) performing welding per the Shielded Metal Arc Welding (SMAW) process to install the patch in the full height shear plate at PP13. See photo below.

The QAI observed QC Inspector Mike Johnson was present periodically to monitor the progress and verify that the welding parameters were within the limits established by the approved Welding Procedure Specifications (WPS) identified as ABF-WPS-D1.5-1090 (horizontal) and ABF-WPS-D1.5-1010-1 (vertical). The welding at this location was completed from the outside of the patch plate upon the arrival of the QAI. See photo below. Mr. Kaddu was observed completing the fillet welding of the patch plate to the bottom plate (bottom flange) from the inside and then performing air carbon arc gouging of the vertical and horizontal seams on the inside. Later in the shift Mr. Kaddu began back welding the vertical seam from the inside. Welding was in process for the duration of

the QA Inspector's shift and appeared to be in general compliance with contract documents.
